Hydraulic State Agency
Ankara

- Diagnostic-feasibility study
- Lake restoration by biomanipulation and metalimnetic aeration

Comprehensive Lake Restoration

Lake Management Planning

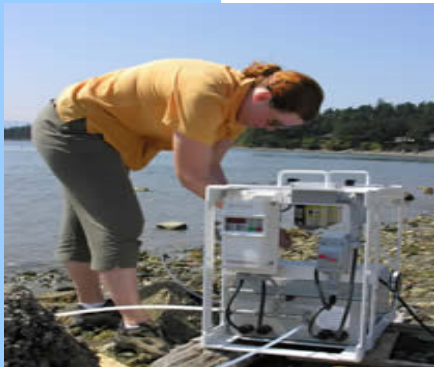
Gentek staff is shown installing runoff flow gaging and automatic sampling equipment. From the samples and data collected, we prepared annual hydrologic and phosphorus budget estimates for each of the five major lakes in the Goller region.
